Worldwide repairs carried out with PolymerMetall®

REP-# 039

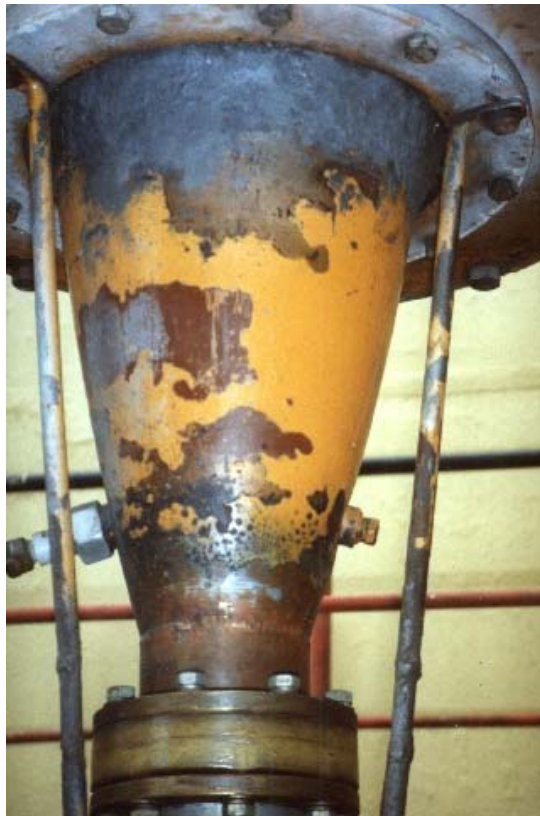
Oil flew through a crack at the cable terminal funnel of a block transformer. The repair was carried out by the method of direct-MM-bonding with MM-metal oL-steelceramic, Hardener red and Hardener yellow.
