Worldwide repairs carried out with PolymerMetal®

REP-# 029

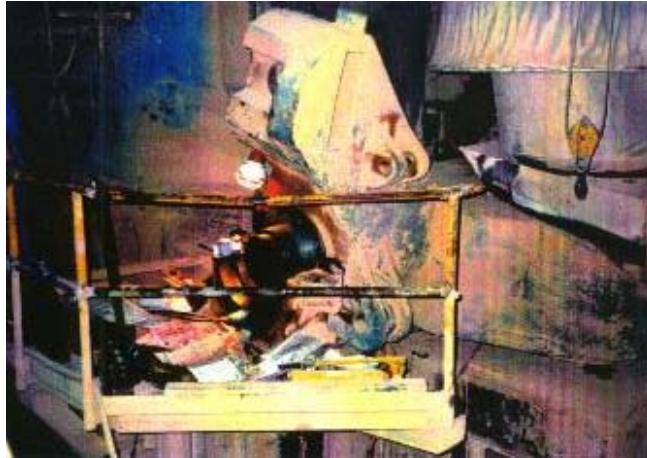
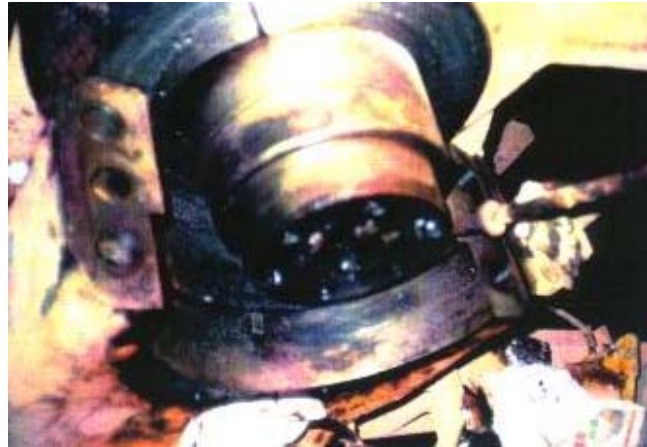
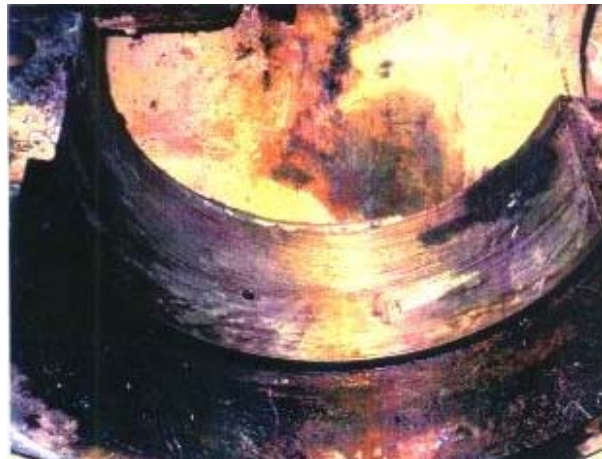
Repair of a grinding machine in a cement company. The damage, a worn out bearing housing, was repaired with MM-metal SS-steelceramic and Hardener yellow. Herewith the previous repair method „resurfacing by welding“ was replaced.
