*Worldwide repairs carried out with PolymerMetal®*

REP-#152

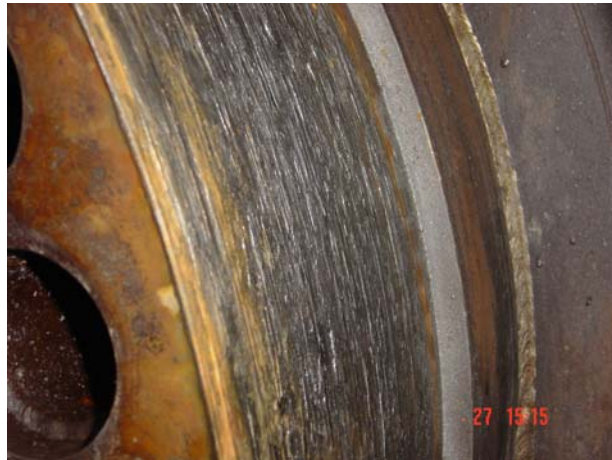
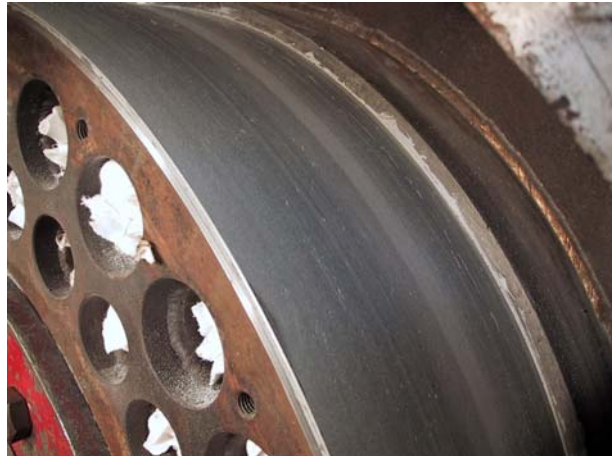
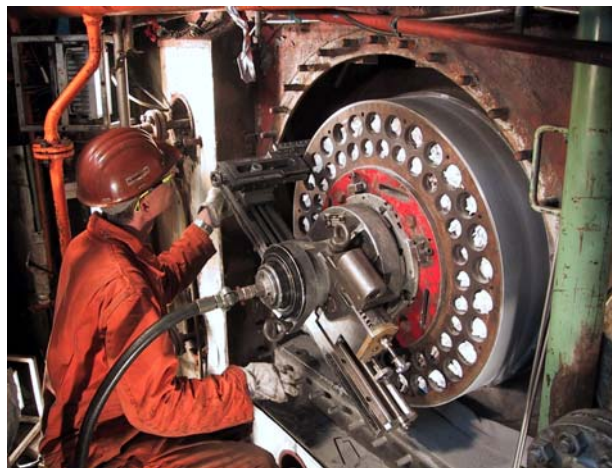
Onto a damaged area of an axle end MM-metal SS-steel, later MM-metal SS-steel 382 was applied to receive a higher surface quality. After curing, the work piece was machined down with a lathe to the desired diameter.
