Worldwide repairs carried out with PolymerMetal®

REP-# 070

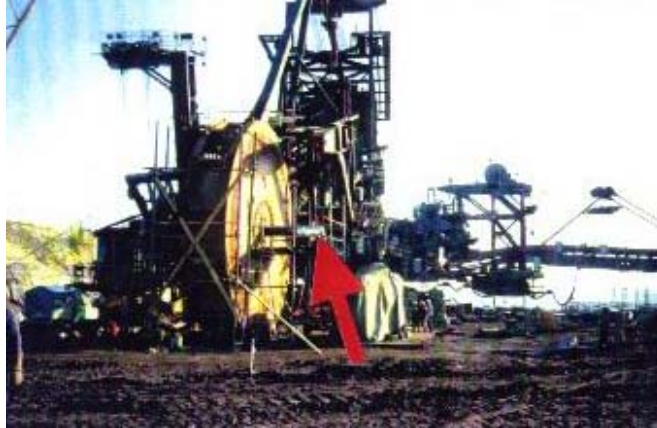
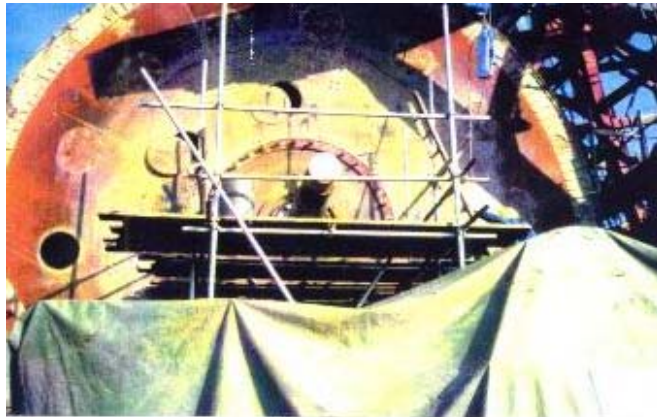
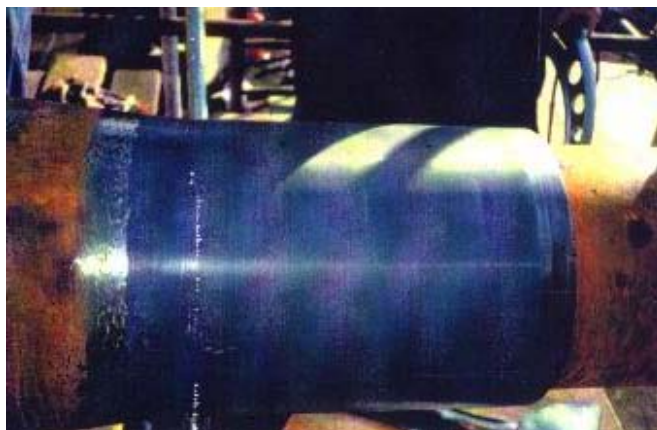
Repair of a bucket wheel excavator for the field of open-cast mining by applying Ceramium liquid. The main drive shaft of the bucket wheel rim, which was damaged due to abrasion, was reconstructed at a length of 400 mm with a diameter of 360 mm. The diameter has been reduced to 350 mm before the rebuilding.
